TEST REPORT

No. : XMIN2411002185CM01_EN

Sample Name : co-extrusion tiles
Product Specification : 300*300*22mm
Style No : STGJ26
Color : light grey
Other Information : Thickness:22

Test Item: Shod Ramp Test

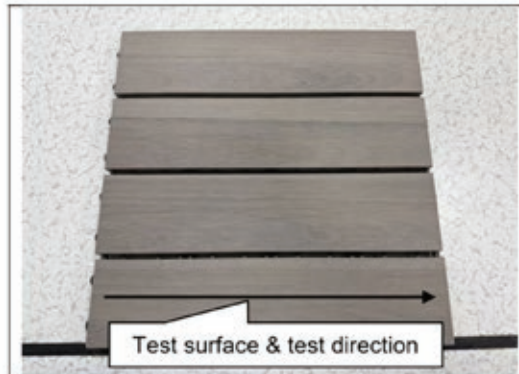
Original Sample Photo:

No.	Test Item	Test Method	Result
1	Shod Ramp Test	DIN EN 16165:2023-02 Annex B	Ramp test value α_{skod} : 17° Slip resistance class: R10

Sample Description: See photo

Specimen: 300mm×300mm, 3pcs form a test surface 900mm×300mm, see photo

Test surface: see photo

Test direction: see photo
